**Flood Control Project Maintenance
Levee Inspections**
LMA District Cover Sheet
Spring 2018 Levee Inspection Results

Reclamation District No. 0999 Netherlands

Spring 2018 Levee Inspection Results

Waterway			Bank	Unit Miles
Unit No. 01 Yolo Bypass			Left	15.41
	Spring (March - May)	Summer (June - August)	(September - November) Fall	Winter (December - February)
Unit Maintenance Rating (Fall Only)				
Date of Inspection	5/8/2018 - 5/8/2018			
DWR Inspector	Dave Torres			
Accompanied By	Tom Slater RD999

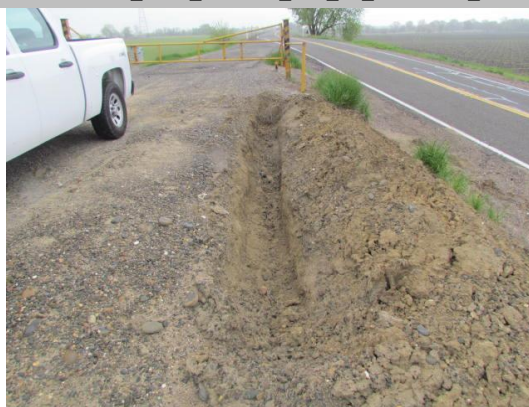
Photo 4 of 4 : SP_2018_RD0999_232_40_20180301_00036.jpg

Looking north at excavation on landside shoulder.

LM Start	3.22	Rating **	M	Issue No.	51
LM End	3.22	Issue Type +	Ma	Location *	LS
Category	Earthen Levee			GPS Latitude/Longitude	
				Start	End
Item	Slope Stability			38.459399 °	38.459399 °
				-121.587523 °	-121.587523 °
DWR ID	DWR_RD0999_01_s_2013_51				
Comment Code					
S1 : Repair slope instability.					
Inspector Comment					
Depression on landward shoulder and slope 40' x 20'. Earthen material appears to be sliding toward levee toe.

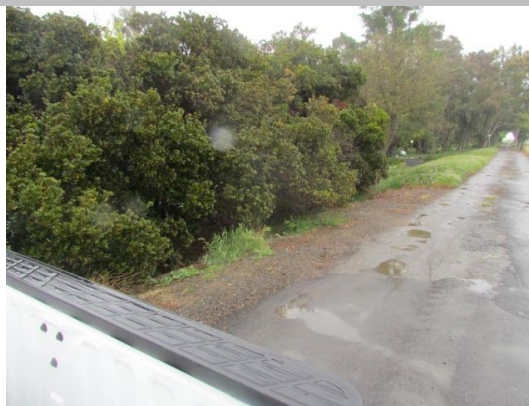
Photo 1 of 1 : SP_2018_RD0999_232_26_20180301_00019.jpg

Looking northwest at dense trees on waterside slope.

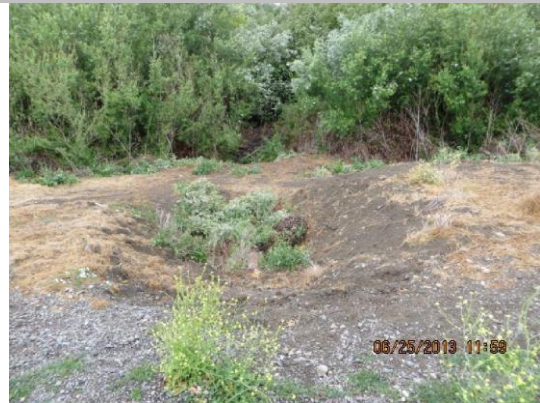
Photo 1 of 3 : UCIP_SP_2018_50097_25415.jpg

Pipe visible in exposed cut on WS slope.

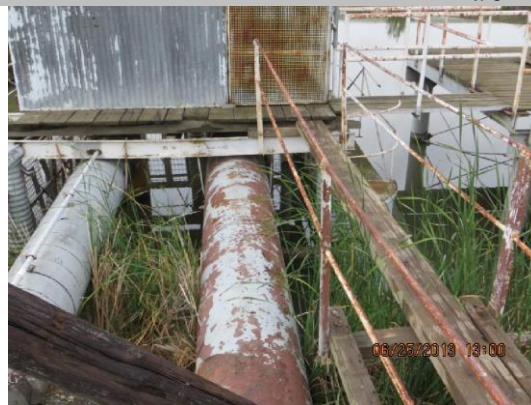
Photo 3 of 3 : UCIP_SP_2018_15365_25225.jpg

Closeup of pipe at pumphouse on LS toe.

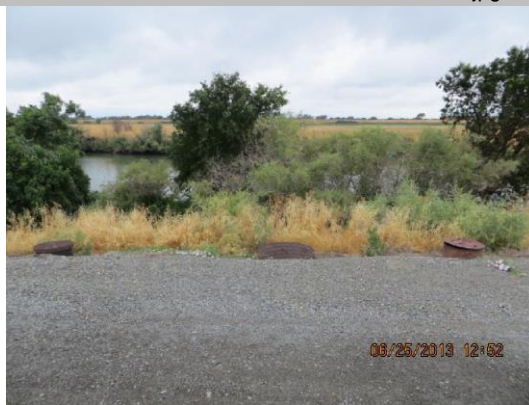
Photo 2 of 3 : UCIP_SP_2018_15363_25218.jpg

Siphon breaker in CMP riser on WS shoulder.

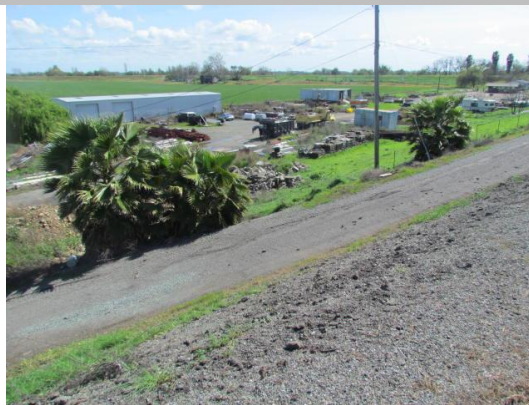
Photo 1 of 2 : SP_2018_RD0999_232_44_20180301_00041.jpg

Looking east at palm trees on landward slope next to ramp.

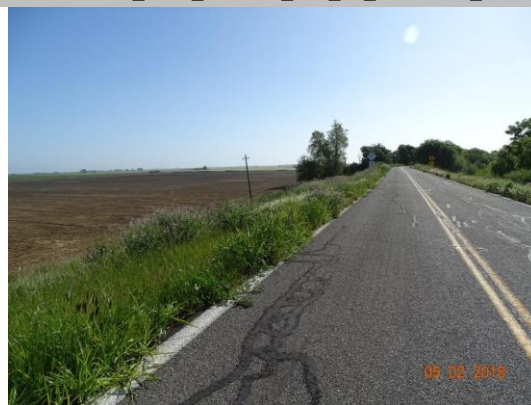
Photo 1 of 1 : SP_2018_RD0999_233_32_20180507_00053.jpg

Vegetation landside looking east.

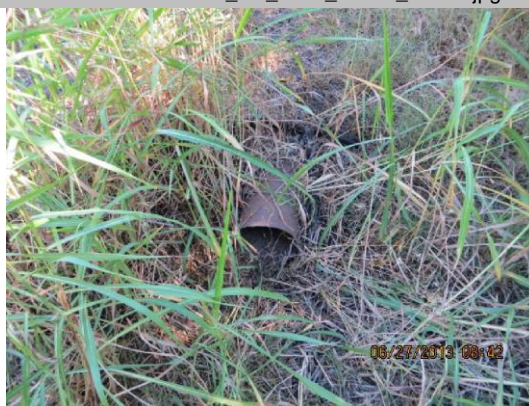
Photo 1 of 3 : UCIP_SP_2018_15384_25242.jpg

Pipe visible at concrete pad on WS slope.

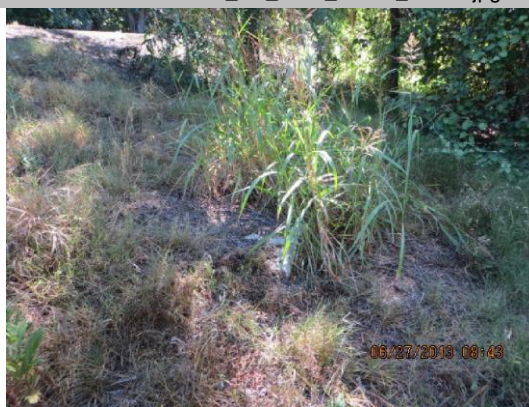
Photo 2 of 3 : UCIP_SP_2018_15384_25241.jpg

Concrete pad on WS slope.

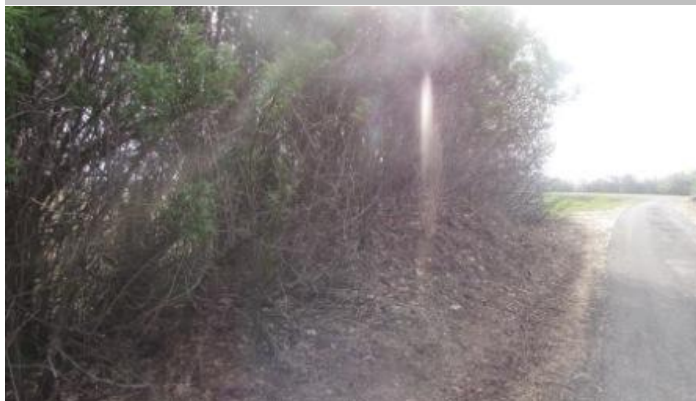
Photo 3 of 3 : SP_2018_RD0999_233_8_20180301_00006.jpg

Looking east at elderberry bush on landside shoulder and slope. (Fall 2014)

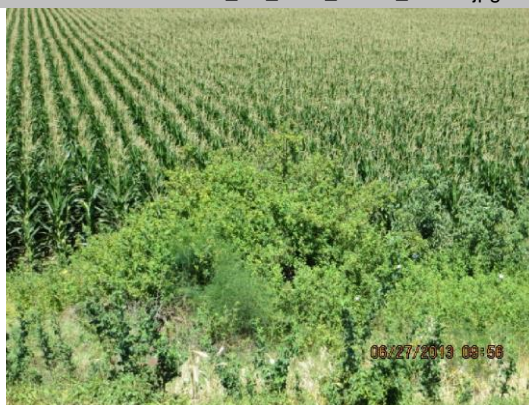
Photo 1 of 3 : UCIP_SP_2018_15389_25254.jpg

Pumphouse on LS slope covered in rose bush.

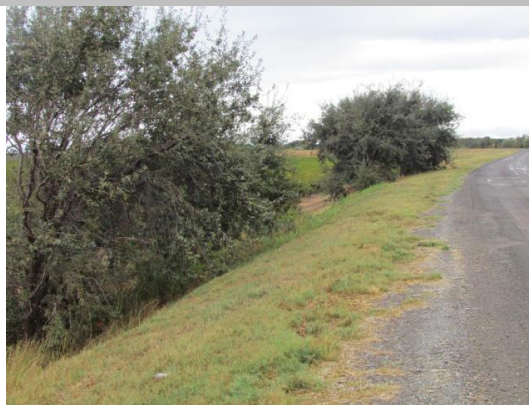
Photo 2 of 2 : SP_2018_RD0999_234_43_20180301_00036.jpg

Looking at untrimmed trees on landward slope and toe.

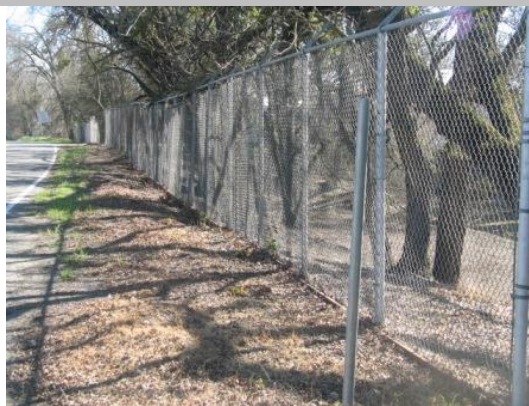
Photo 1 of 1 : SP_2018_RD0999_235_13_20180301_00011.jpg

Cyclone fence along landside shoulder at LM 0.05 -0.11

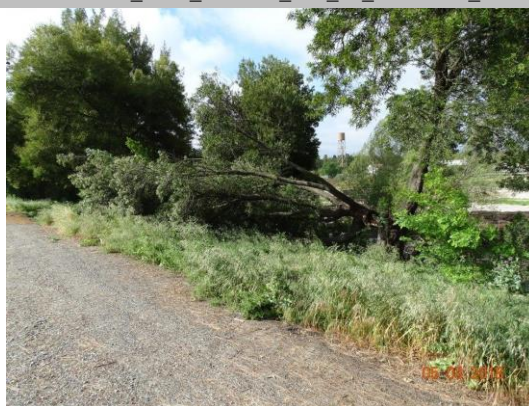
Photo 1 of 1 : SP_2018_RD0999_235_33_20180503_00085.jpg

Downed tree landside looking southwest.

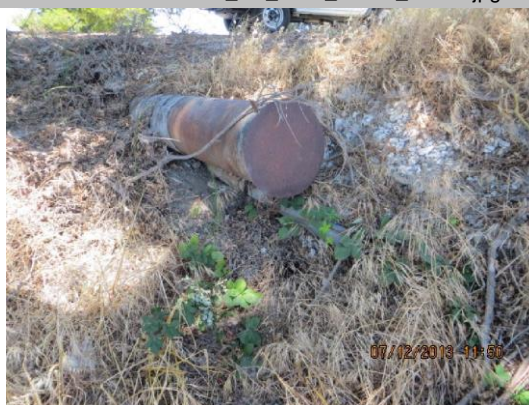
Photo 1 of 2 : UCIP_SP_2018_16389_27669.jpg

Pipe with steel plate welded over WS end.

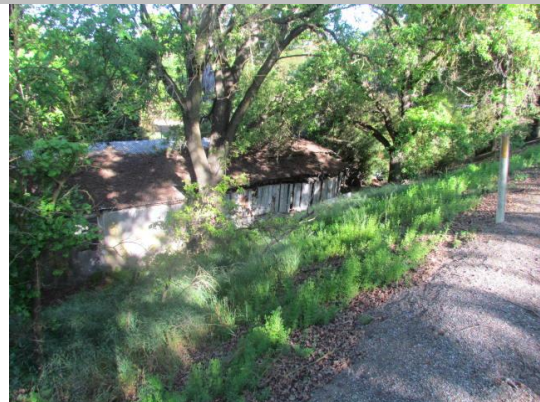
Photo 1 of 2 : SP_2018_RD0999_236_23_20180301_00019.jpg

Looking northwest at abandoned storage shed at landward toe. (Spring 2015)

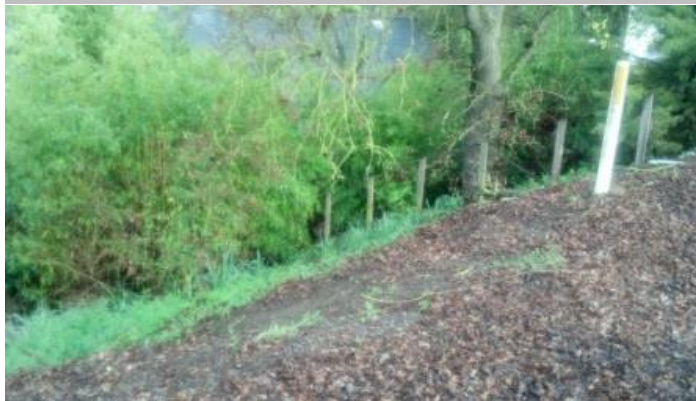
Photo 2 of 2 : SP_2018_RD0999_236_128_20180301_00062.jpg

Looking at dense trees on landside slope and toe.

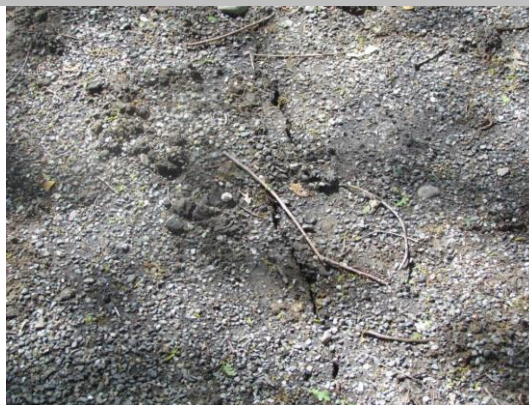
Photo 2 of 3 : SP_2018_RD0999_236_167_20180301_00087.jpg

Looking at crack along waterward cause by poles.

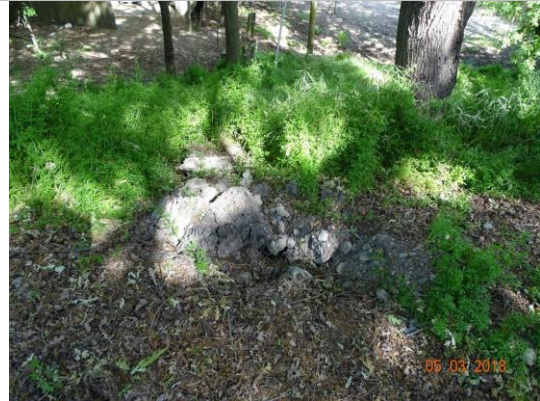
Photo 1 of 1 : SP_2018_RD0999_236_69_20180503_00198.jpg

Erosion landside looking west.

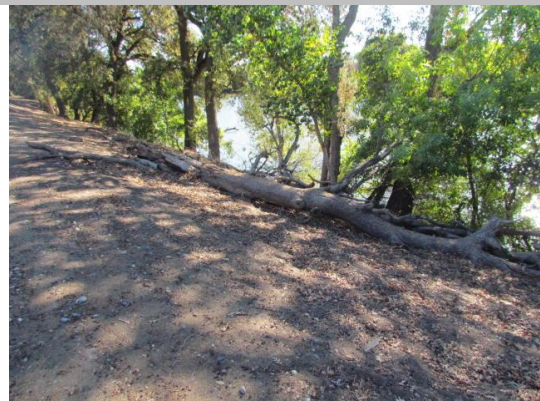
Photo 1 of 1 : SP_2018_RD0999_236_174_20180301_00096.jpg

Looking at downed tree branch on waterward slope.

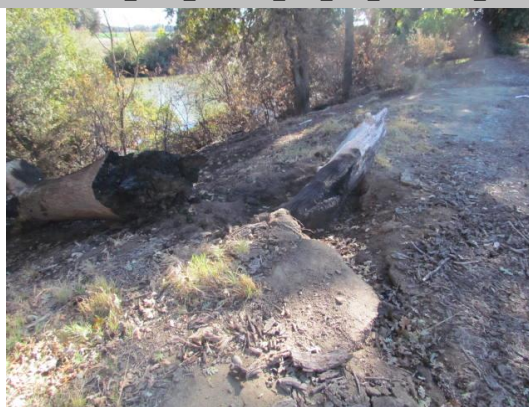
Photo 3 of 3 : SP_2018_RD0999_236_176_20180301_00099.jpg

Looking at fallen tree and hole on waterward slope and shoulder.

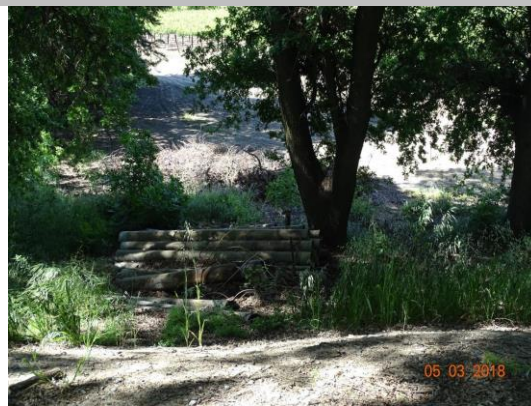
Photo 1 of 1 : SP_2018_RD0999_236_77_20180503_00199.jpg

Poles stored at landside toe looking northwest.

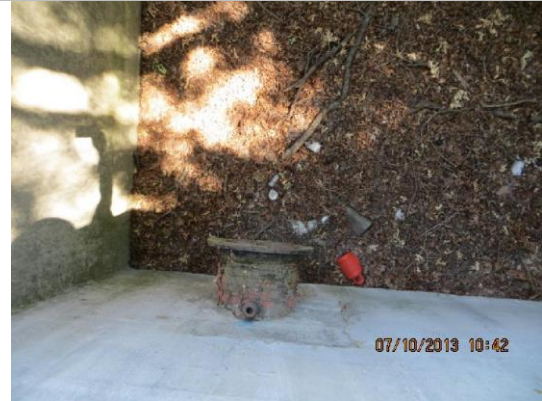
Photo 3 of 3 : UCIP_SP_2018_50096_25936.jpg

Pipe open at pump pit on WS toe.

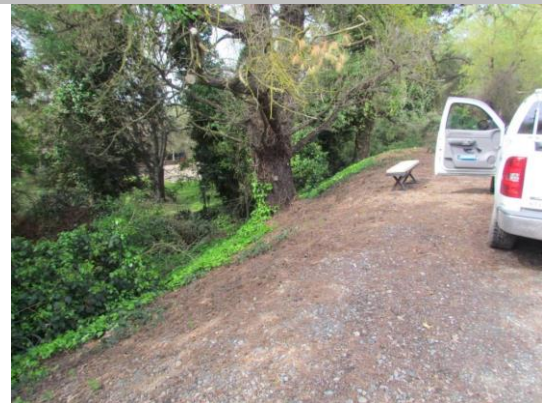
Photo 1 of 2 : SP_2018_RD0999_236_66_20180301_00037.jpg

Looking east at landscaping at bottom half of levee. (Spring 2017)

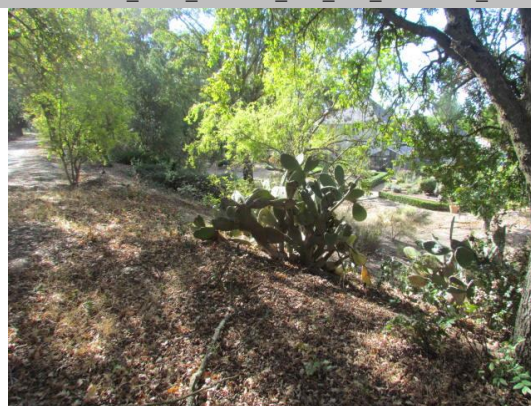
Photo 1 of 1 : SP_2018_RD0999_236_127_20180301_00060.jpg

Looking west at cactus and other vegetation on landward slope.
